Anti Head in Pillow Defect

PF305 - 153TO^{Alloy Composition : Sn-3.0Ag-0.5Cu} Flux : Halogen Free, ROL0 in IPC standards

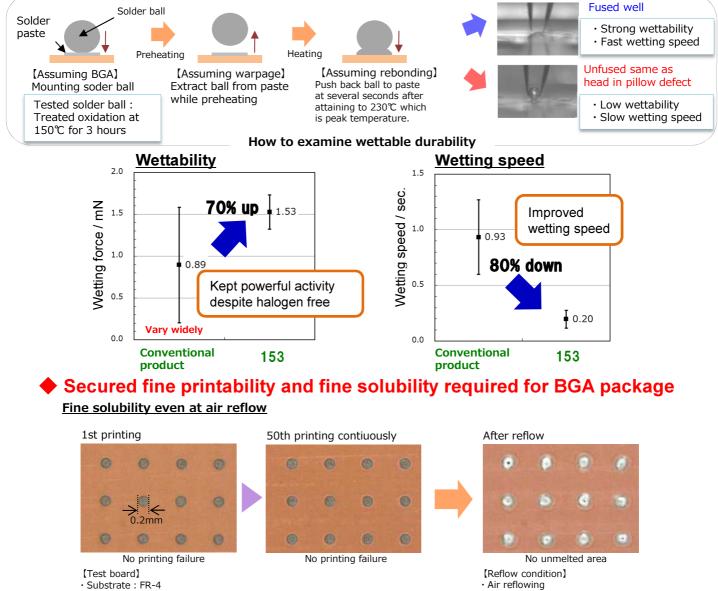
Strong wettable durability inhibits head in pillow defect

We checked quantification of wettability with an exclusive apparatus to measure wetting force and wetting speed.

Mask : 0.2mmΦ and 0.12mmT

· Air reflowing

• Preheating 100sec at 180 to 190℃

· Peak temp. 240℃, 26sec for 220℃
